EXHIBIT A

First results from epitaxial GaN detectors

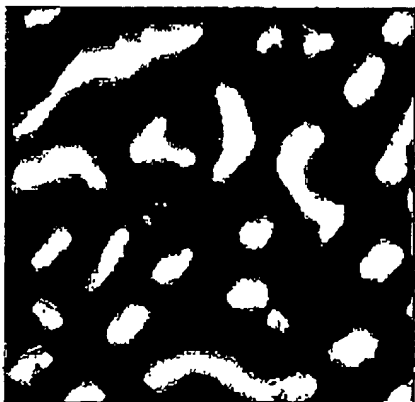
Epitaxial GaN tends to show a highly defective, ordered polycrystalline growth with a columnar structure - on a nanometre length scale.

AFM images of epitaxial GaN samples. Image size is 2µm x2µm
